**PRELIMINARY ASSESSMENT/
VISUAL SITE INSPECTION**

**MORGAN MATROC, INC
(FORMERLY VERNITRON PIEZOELECTRIC DIVISION)
BEDFORD, OHIO
OHD 052 324 290**

FINAL REPORT

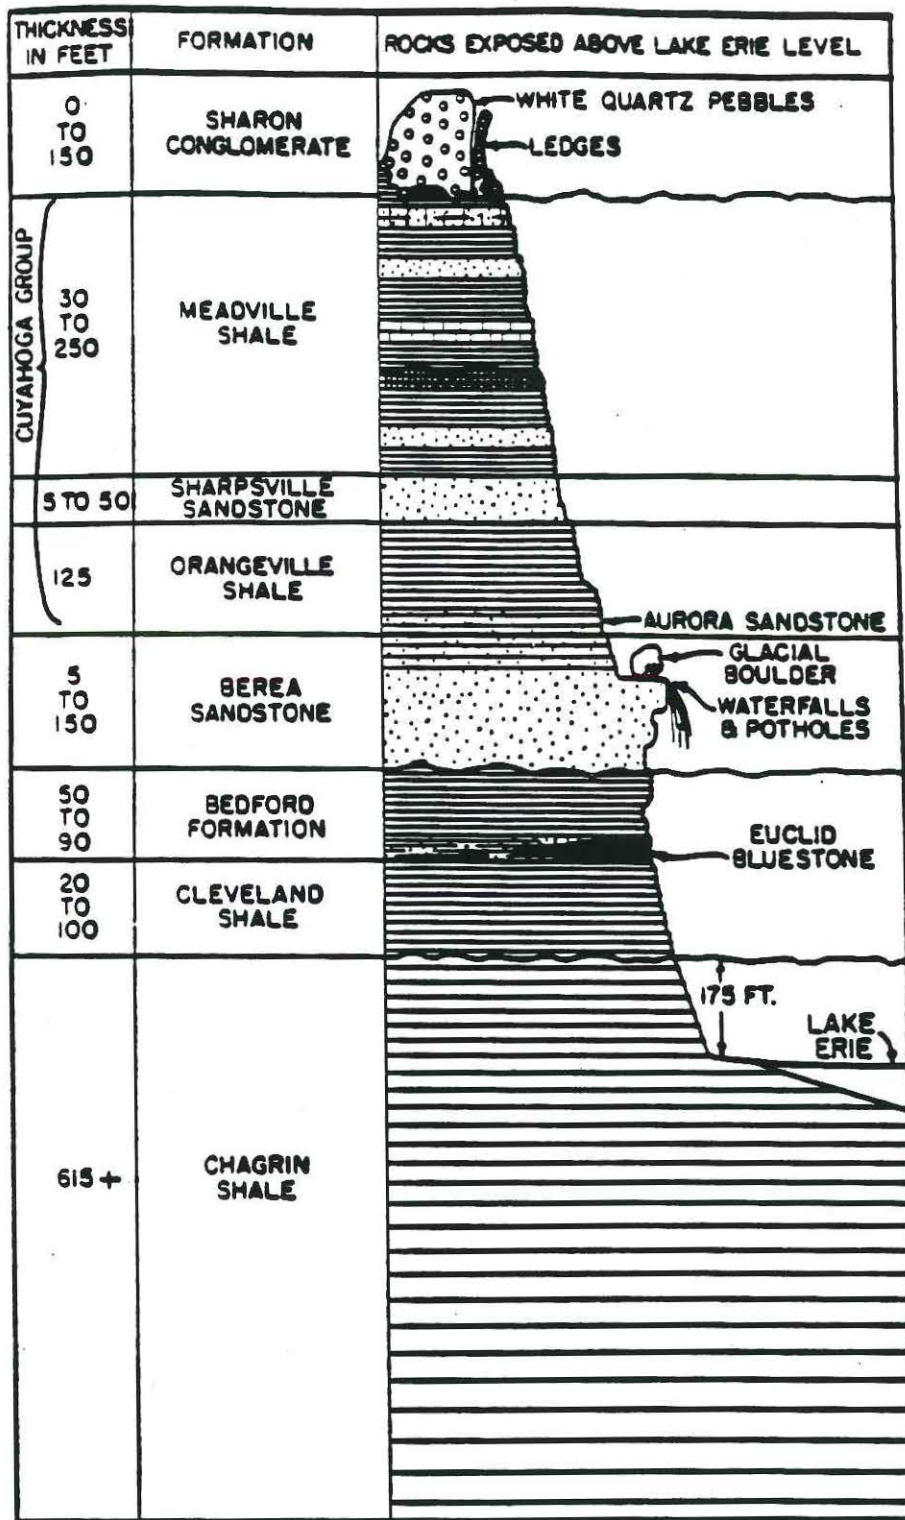
FIGURE 5
REPRESENTATIVE GEOLOGIC CROSS-SECTION
OF THE CLEVELAND AREA

As seen in Figures 3 and 4, the rock sections in the Cleveland area, separated by varying thicknesses of weak shale, mark the surface of the Appalachian Plateau and the two lesser platforms on the slope of the Portage escarpment. The uppermost of the rocks in this formation is the Sharon conglomerate, of lower Pennsylvanian age. It is the youngest exposed Paleozoic rock in this area, and is the capstone formation of the plateau across northeastern Ohio. Below the Sharon conglomerate, other formations include: the Orangeville and Meadville shales from the Mississippian age; the Cleveland and Bedford shales, classified by some as upper Devonian and by

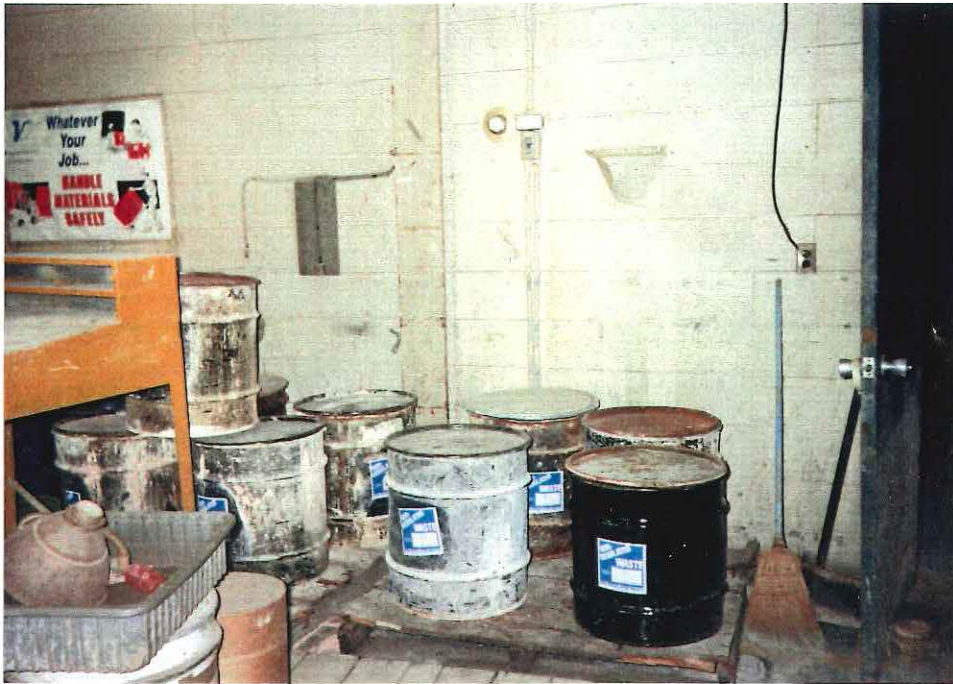
Photograph No. 1

- Observations:** During the VSI, 55-gallon steel drums containing perchloroethylene and ethanol were staged on the concrete floor. The drums appeared in good condition. Lead-containing solids in 30-gallon metal drums were staged on pallets. No cracks or expansion joints were observed in the floor where drums were stored. No visible stains or other signs of release were observed during the VSI.

Location: SWMU 1

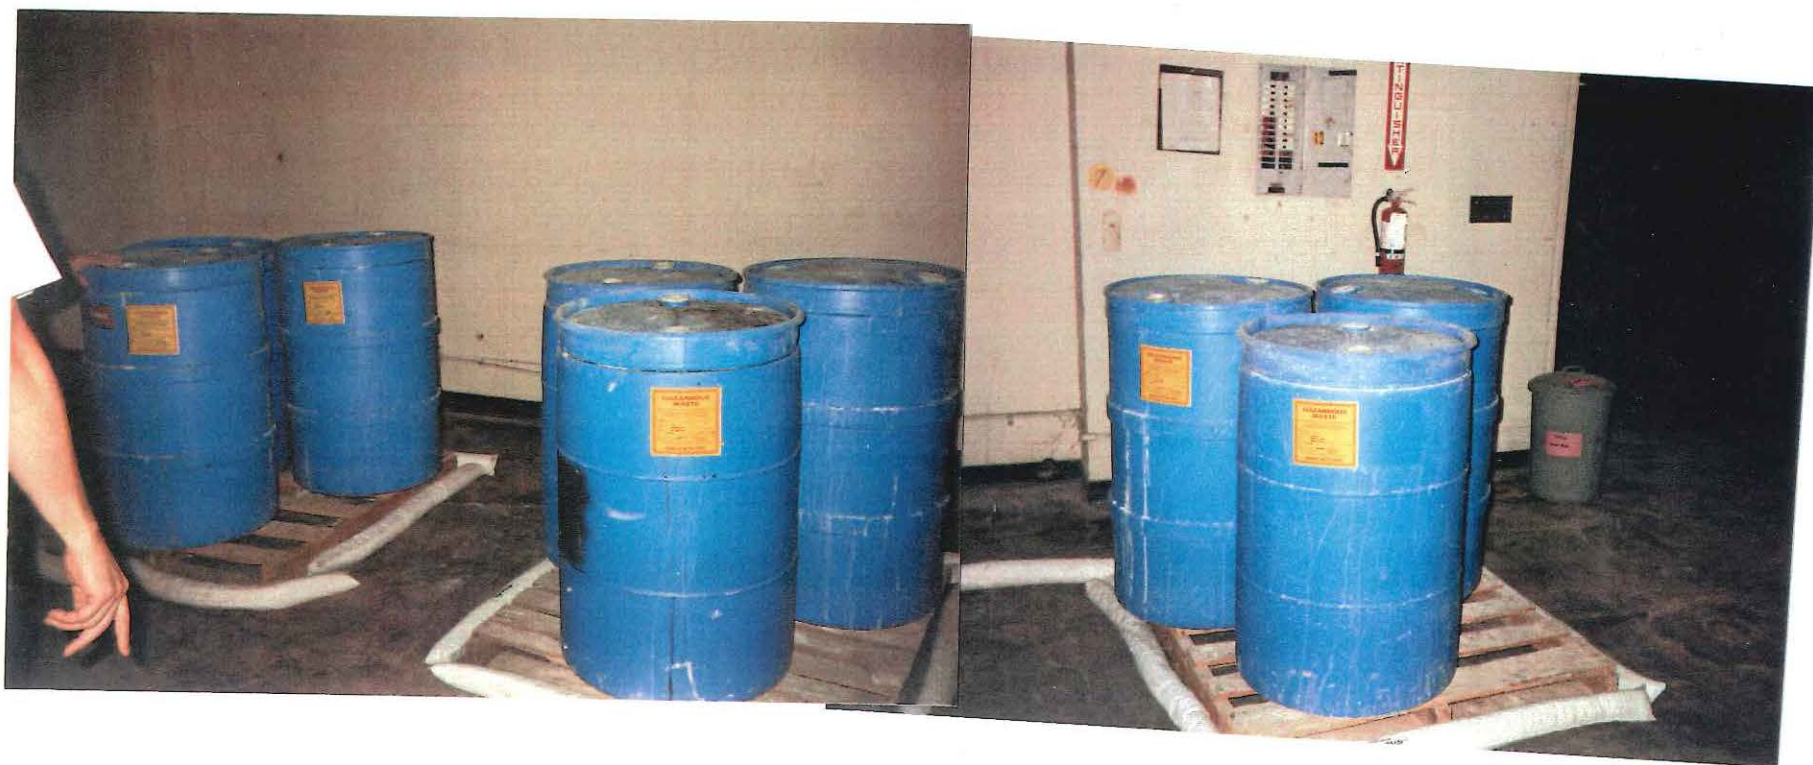
Photograph No. 3

Observations: During the VSI no releases were observed from this area. The area appeared to be in satisfactory condition. Nine drums containing the nickel solution were staged on pallets on a concrete floor. No cracks were observed in the concrete. All of the drums were in good condition.

Location: SWMU 2

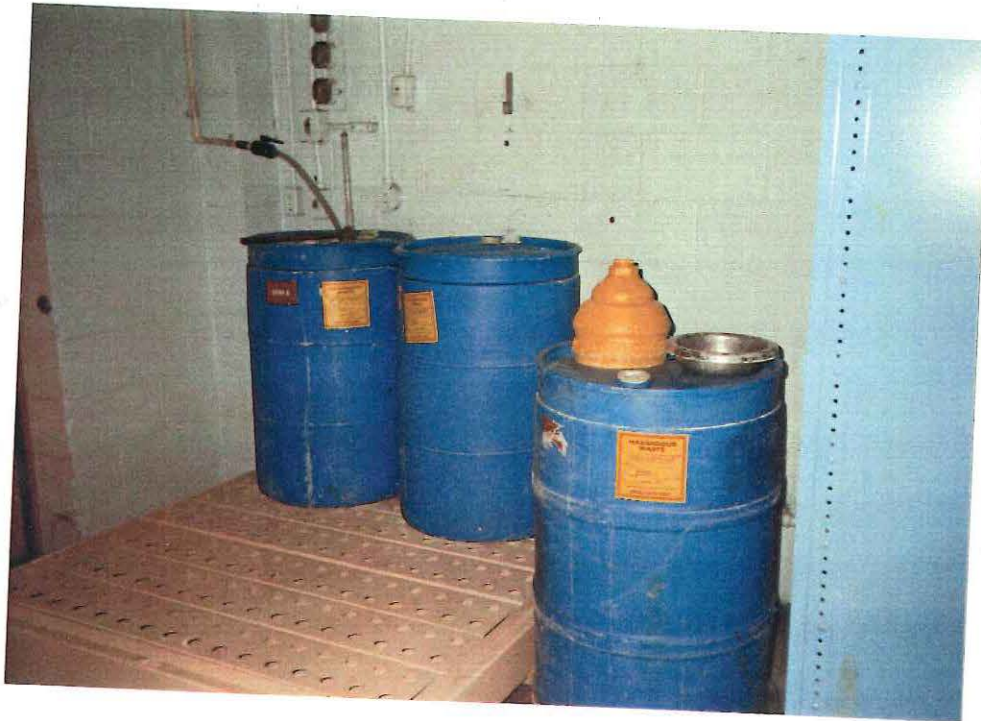
Photograph No. 4

Observations: During the VSI, two drums containing spent electroless nickel-plating solution and cleaning brass solution, respectively, were accumulated at this area. The secondary containment system appeared to be in sound condition. A third empty drum was located outside the secondary containment system on the concrete floor. No stains or signs of releases were observed.

Location: SWMU 3

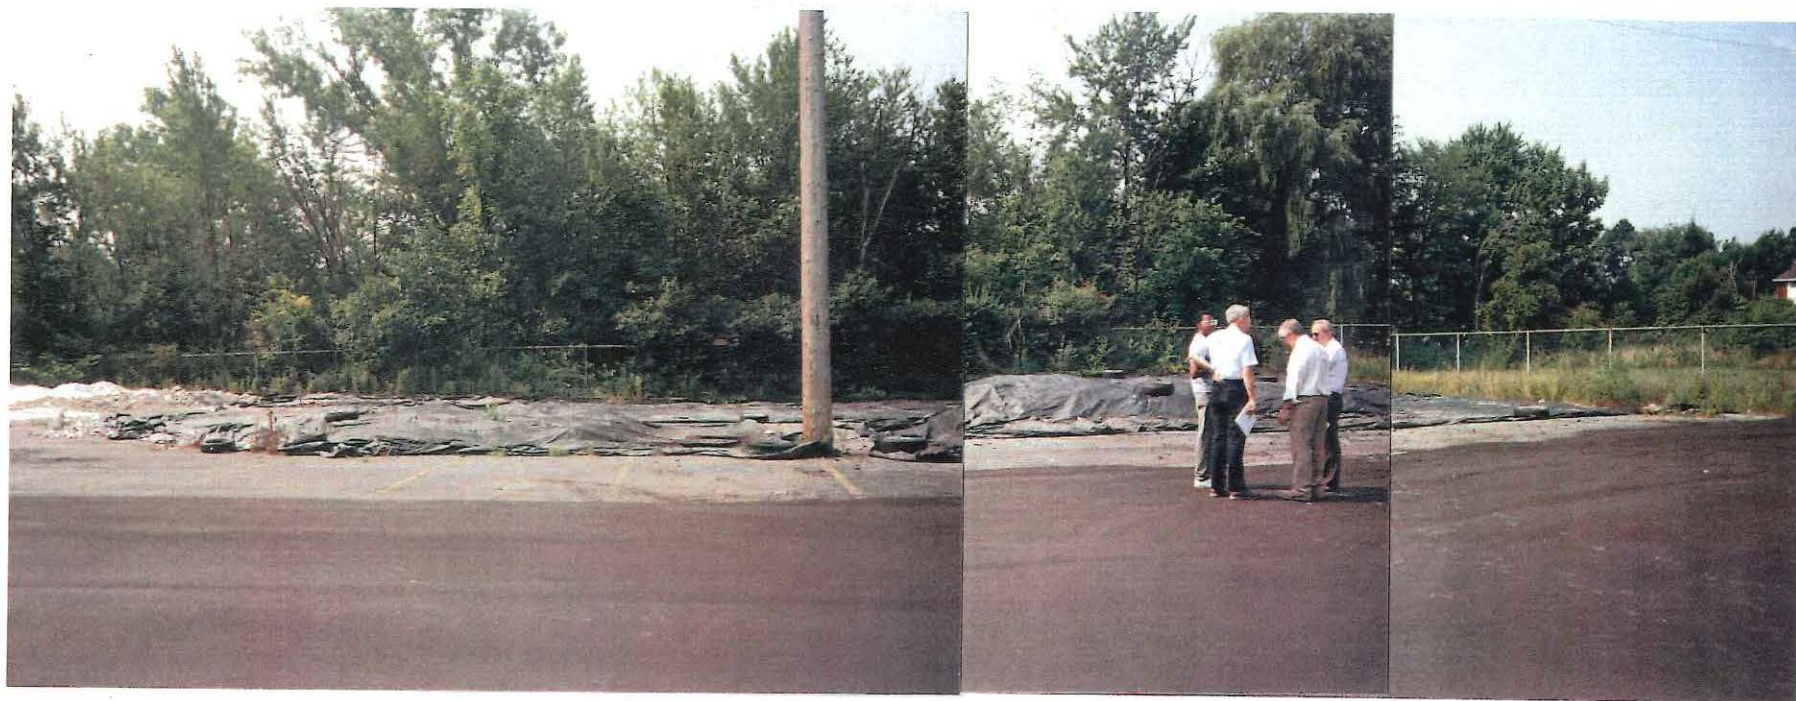
Photograph No. 5

History of Release: During the closure cleanup in August 1988, portions of soil below the asphalt pavement were observed to be stained. Two verification samples were taken from areas where corroded asphalt had been removed. The samples were analyzed for volatiles, semivolatiles, and metals. The samples were found to contain elevated levels of metals and organics. Groundwater samples taken from monitoring wells installed in the upper aquifer also contained elevated levels of volatile organics. Lead was detected at concentrations below the Primary Drinking Water Standards of 0.05 mg/L (40 CFR 141.11). Moreover, asphalt left in place was found to contain elevated levels of metals and organics (Vernitron, 1988).

Observations: During the VSI, about 36 cubic yards of excavated material was covered with polyethylene liner. The liner appeared to be in good condition with no holes. According to Morgan Matroc's representative, Vernitron's contractor, Toxcon planned to ship this material to an off-site landfill. Because of the level of contamination identified, disposal of the soil has been delayed. The excavated material will be sent off site according to the approved closure plan.

Location: SWMU 6

Recommendations: This area has not been brought to clean closure standards required by U.S. EPA or Ohio EPA. Vernitron is conducting further investigations to complete delineation of the extent of contamination. In addition, Vernitron is studying the feasibility of using an air stripper to remediate contaminated ground water and soil venting to remediate contaminated soil. PRC suggests that the unit should be closed in accordance with the approved closure plan. This includes collecting soil and ground-water samples to determine the extent of contamination in the area.

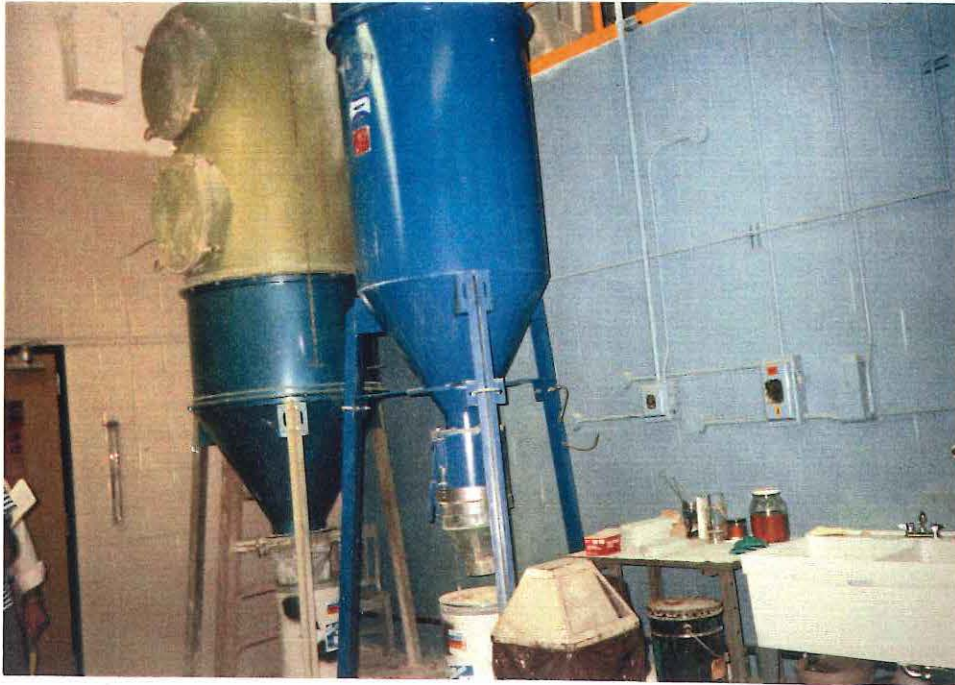
Photograph No. 6

Description: Dust collectors located in the machining area are shown. They are equipped with 55-gallon fiber drums that receive dust.

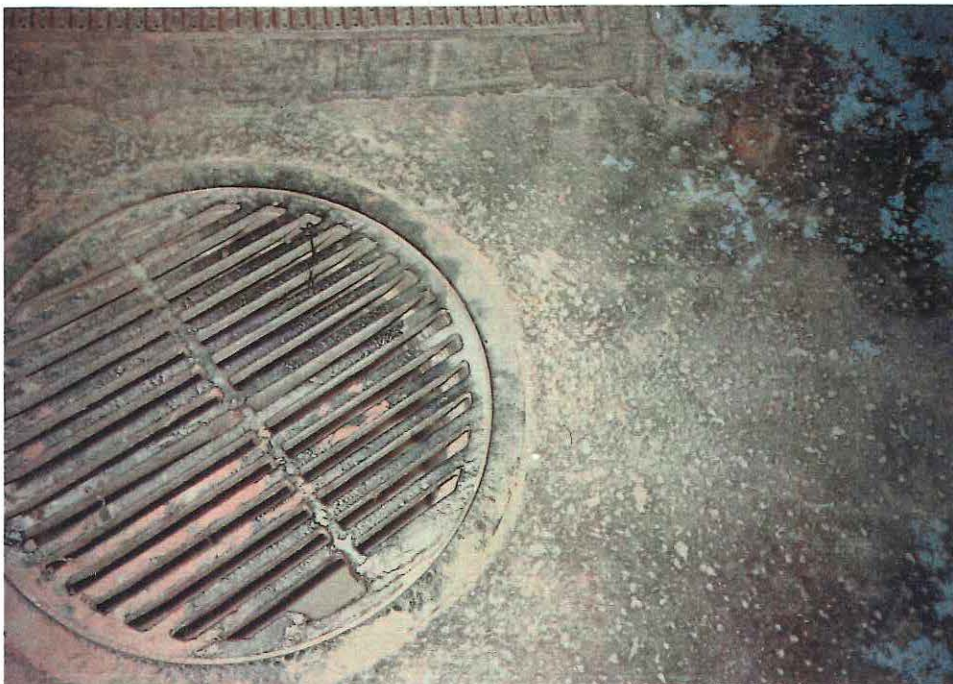
Photograph No. 7

Description: Sump in the powder preparation area is shown. There are five such sumps in this area.

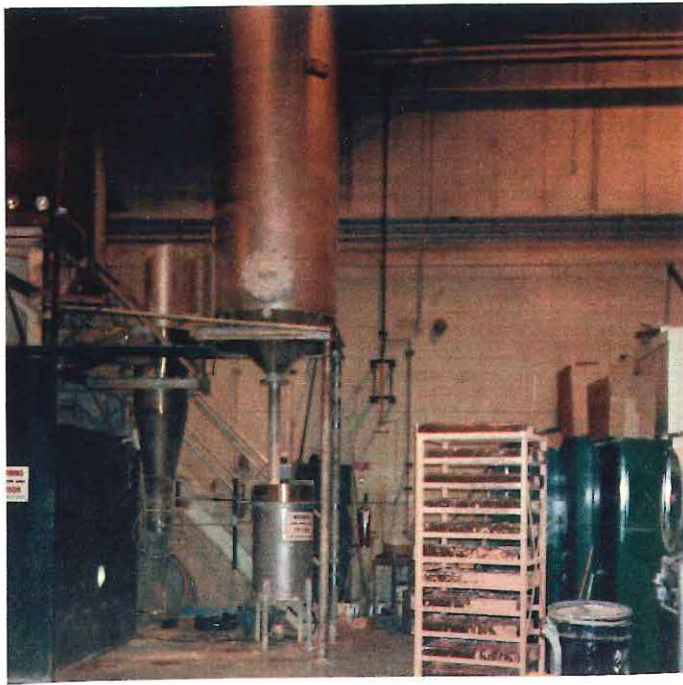
Photograph No. 8

Location: SWMU 10

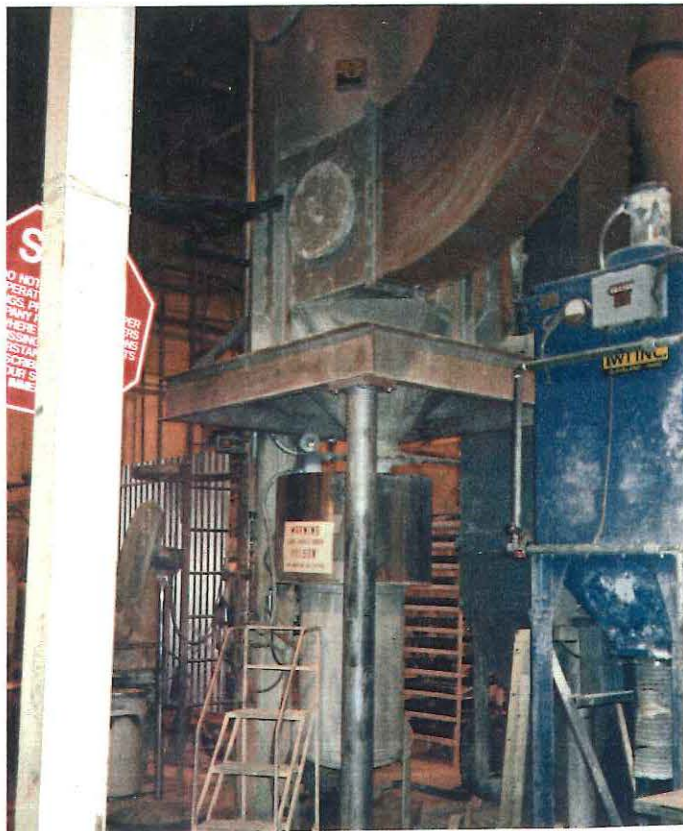
Photograph No. 9

Unit Description: This unit is located in the powder preparation area. The wet scrubber is equipped with a settling basin beneath it. The location of this unit is shown in Figure 2. Photograph 9 depicts this SWMU.
